CUP/LINER CONFORMITY OF METAL-BACKED ACETABULAR DESIGNS

**Orthopaedic Research Laboratories
The Mt. Sinai Medical Center
Cleveland, Ohio 44106**

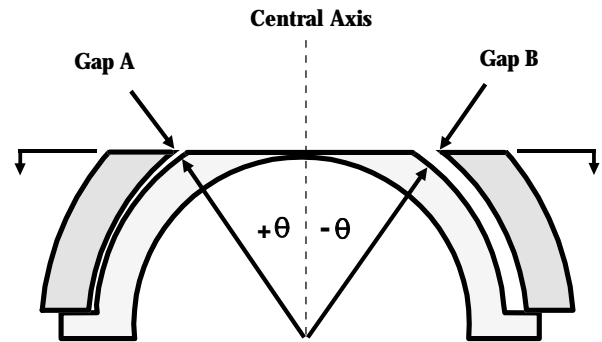
Figure 1A

Figure 1A. A cup section indicating locations for gap measurements. 1B. A section through a cup in a plane normal to the central axis, illustrating polyethylene offset within the metal shell.

As shown in Figure 1A, gap dimensions were recorded through ranges of approximately ± 90 degrees relative to the central axis. In areas of complex geometry and in areas where gap dimensions approached the 0.20 mm gap criterion, readings were taken at 1 degree intervals. Otherwise, readings were taken every 5 degrees. When no gaps were present at any $\pm\theta$, the polyethylene circumference, swept in a plane normal to the central axis, was assumed to be entirely supported. Conversely, when gaps were present at both $\pm\theta$, the polyethylene circumference was assumed to be entirely unsupported. However, if supported polyethylene was indicated at any θ and unsupported at the opposite angle, the polyethylene and metal circumferences were modeled to resemble a circle of radius R_1 offset within a circle of radius R_2 , where R_1 is less than R_2 , as shown in Figure 1B. Subsequently, at this angle, the supported length around the circumference up to the location of 0.20 mm separation was determined.

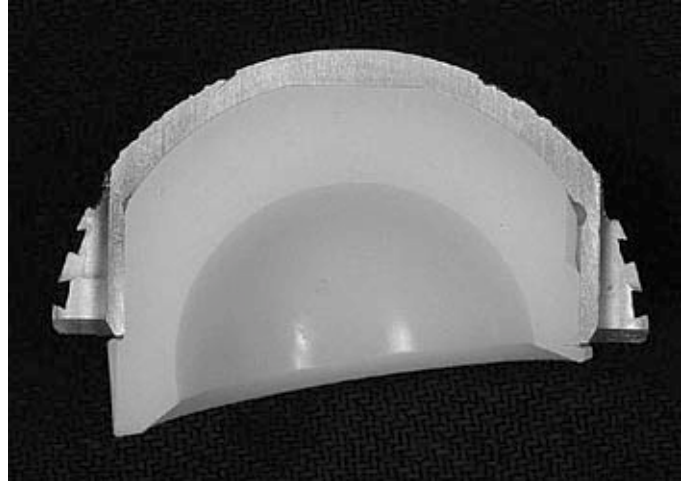
Elliptical

- Minimum Hole Geometry:
(0) No Holes
Other Hole Geometries:
None
Factory Pre-assembled

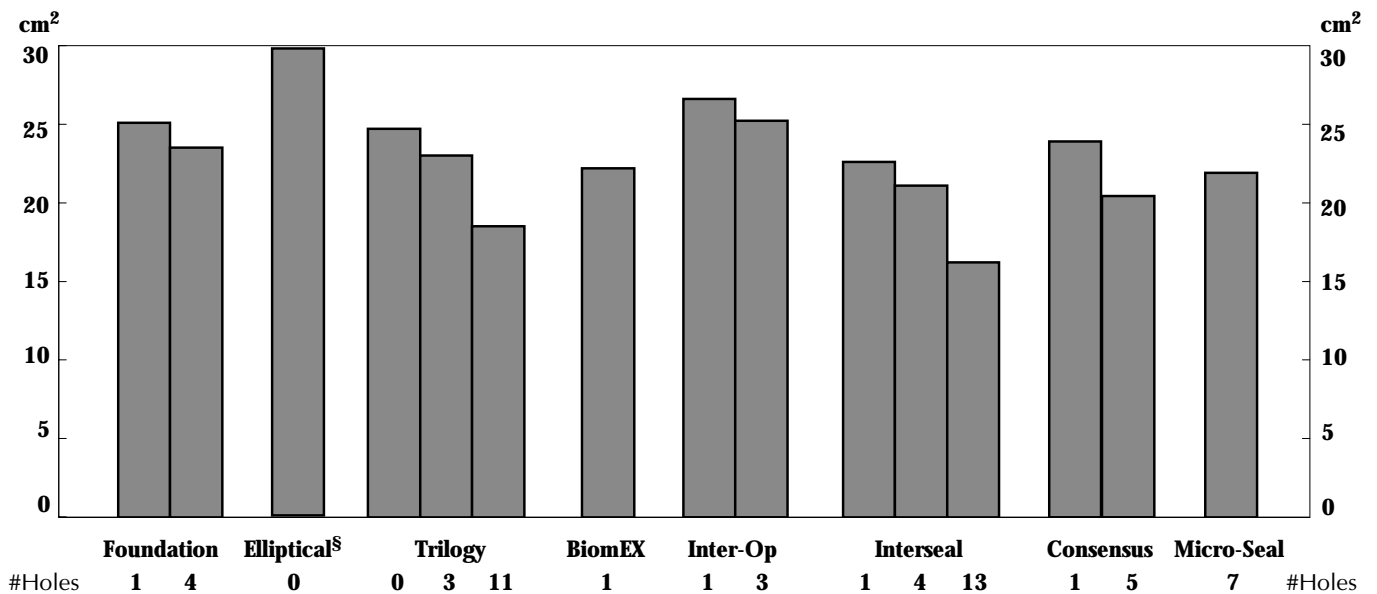
Contact Area of Supported Polyethylene

Figure 3. Median contact area of supported polyethylene for two piece acetabular designs.

The cup sections presented are of the minimum hole configuration of each system. Figure 2 describes the median percent of unsupported polyethylene in each cup, covering the outer polyethylene surface up to, but not including the rim. Hole and gap information are presented separately for each acetabular cup design. The range of unsupported polyethylene in the cups studied was 3.3% to 41.8% as evidenced in Figure 2. Supported regions of polyethylene were characterized by the area of conformity up to, but not including the rim. Figure 3 demonstrates median areas of contact for each system, which ranged between 29.7 cm² and 16.2 cm² for the designs evaluated.

While it is valuable to understand the causes of nonconformity, the areas of conformity, shown in Figure 3, suggest an absolute context by which stress transfer may be inferred. The goal to increase conformity is synonymous with the goal to increase contact area. Although certain locales of contact will be of much greater relevance than others for stress transfer in any single loading condition, dynamic loading in common activities such as gait suggest the necessity for contact over a relatively wide range. An increase in contact area will reduce stress-induced redefinition of the polyethylene surface, as well as inhibit the catalysis of wear mechanisms.
